NASA TN D-563

# INVESTIGATION OF S-IV ALL SYSTEMS VEHICLE EXPLOSION

*George C. Marshall Space Flight Center  
Huntsville, Ala.*

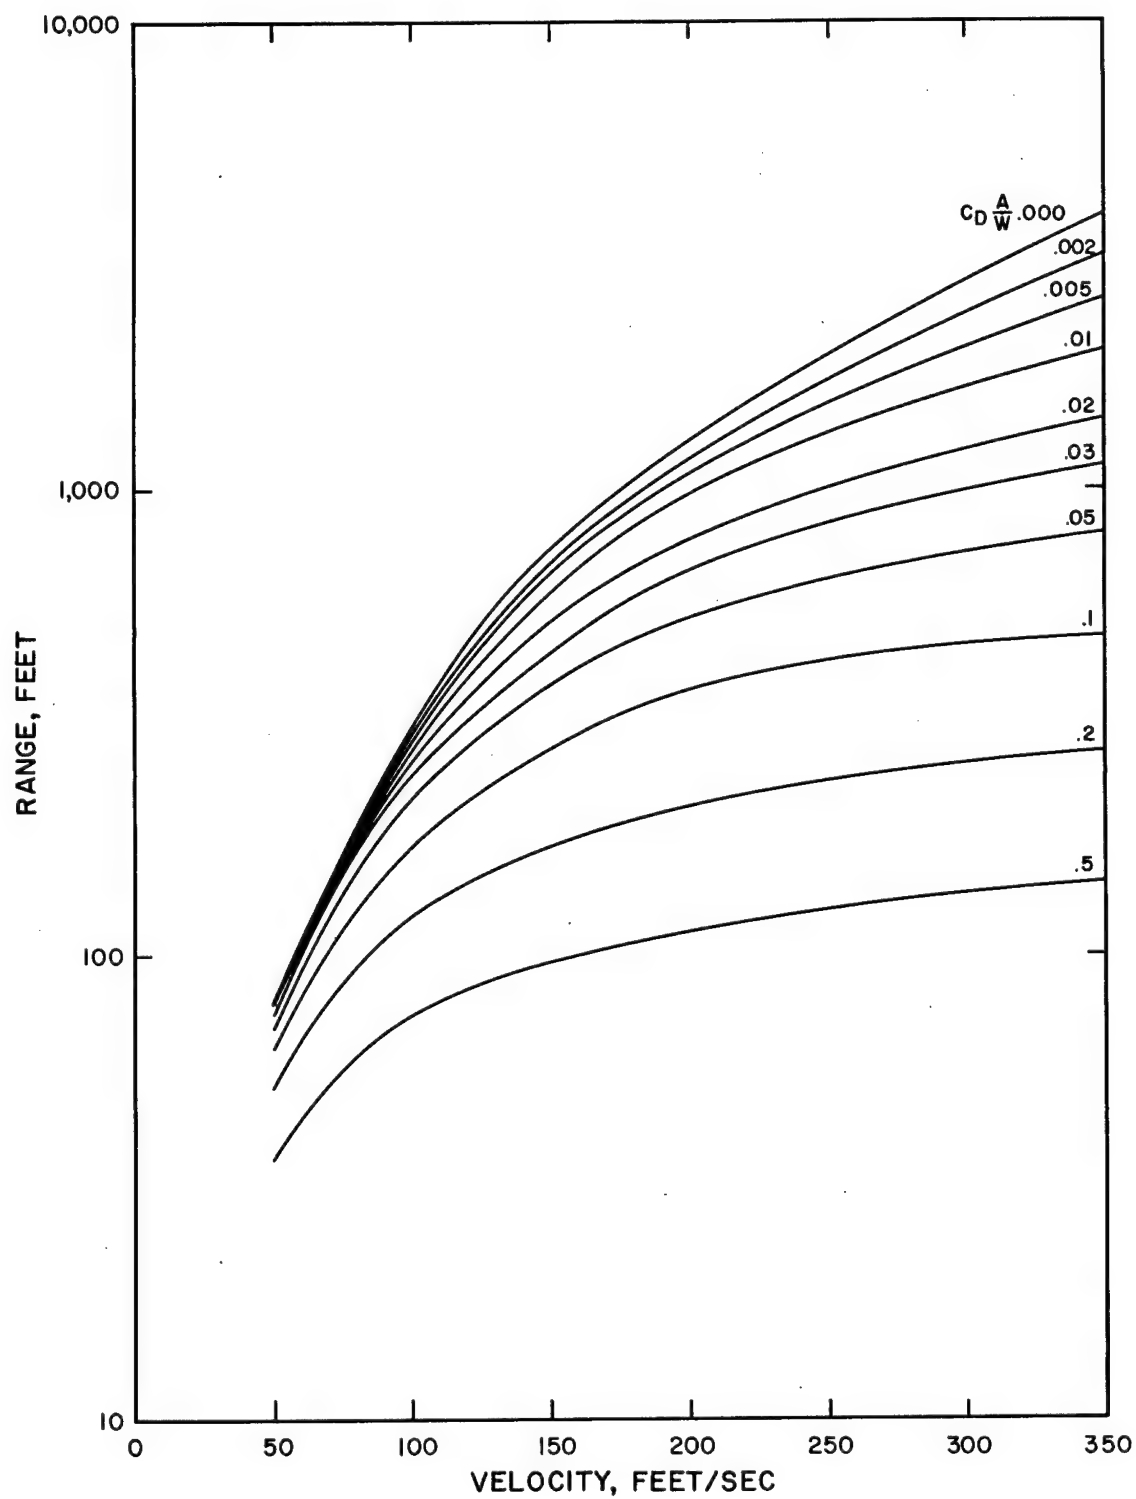
FIGURE 12. RELATION BETWEEN INITIAL VELOCITY AND GROUND RANGE  
(LOW VELOCITY RANGE)

Figures 12 and 13 indicate the relation between initial velocity and distance traveled for fragments of different drag coefficients, cross sectional areas, and weights using an assumed flight angle of 45°. Table IV gives the identities and pertinent data for selected fragments from the S-IV All Systems Vehicle explosion and initial velocities estimated from FIG 12 and 13.

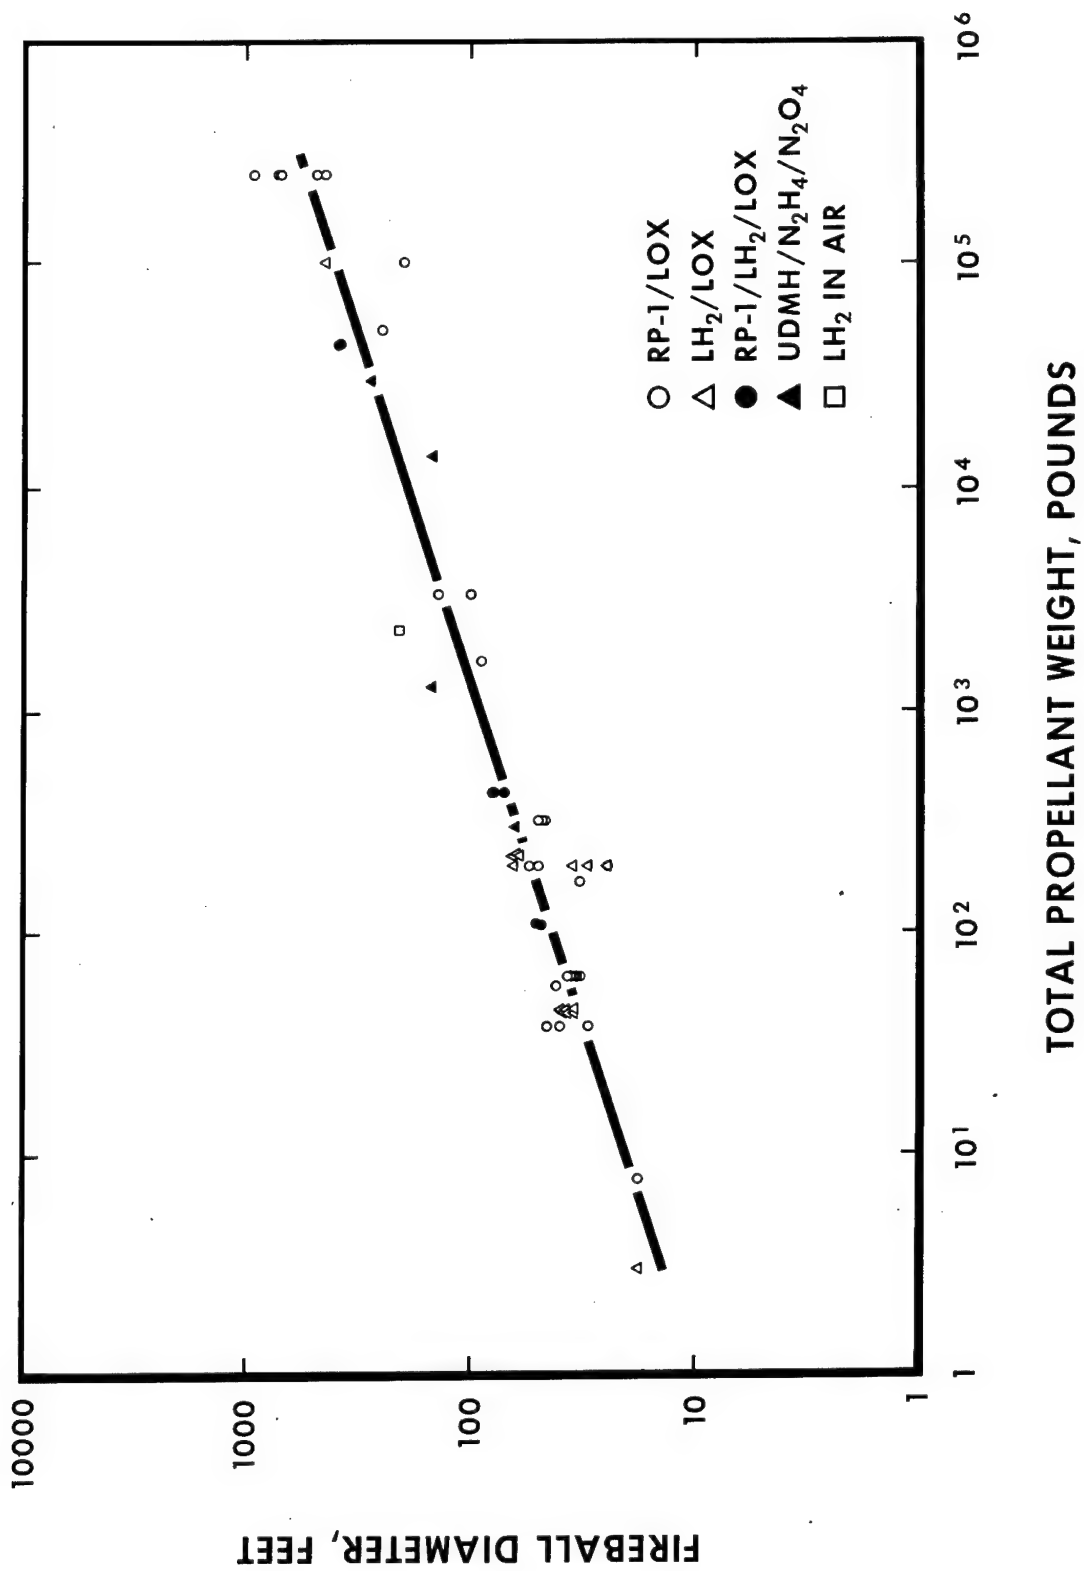
FIGURE 15. FIREBALL DIAMETERS FOR VARIOUS WEIGHTS AND TYPES OF PROPELLANTS

Figure 15 shows the maximum diameter attained by the fireball with similar values derived from small scale experimental tests and full scale vehicle failures involving LOX/RP-1 and LOX/LH<sub>2</sub> and N<sub>2</sub>O<sub>4</sub>/Aerozine 50. The data are logarithmically related in accordance with the equation:

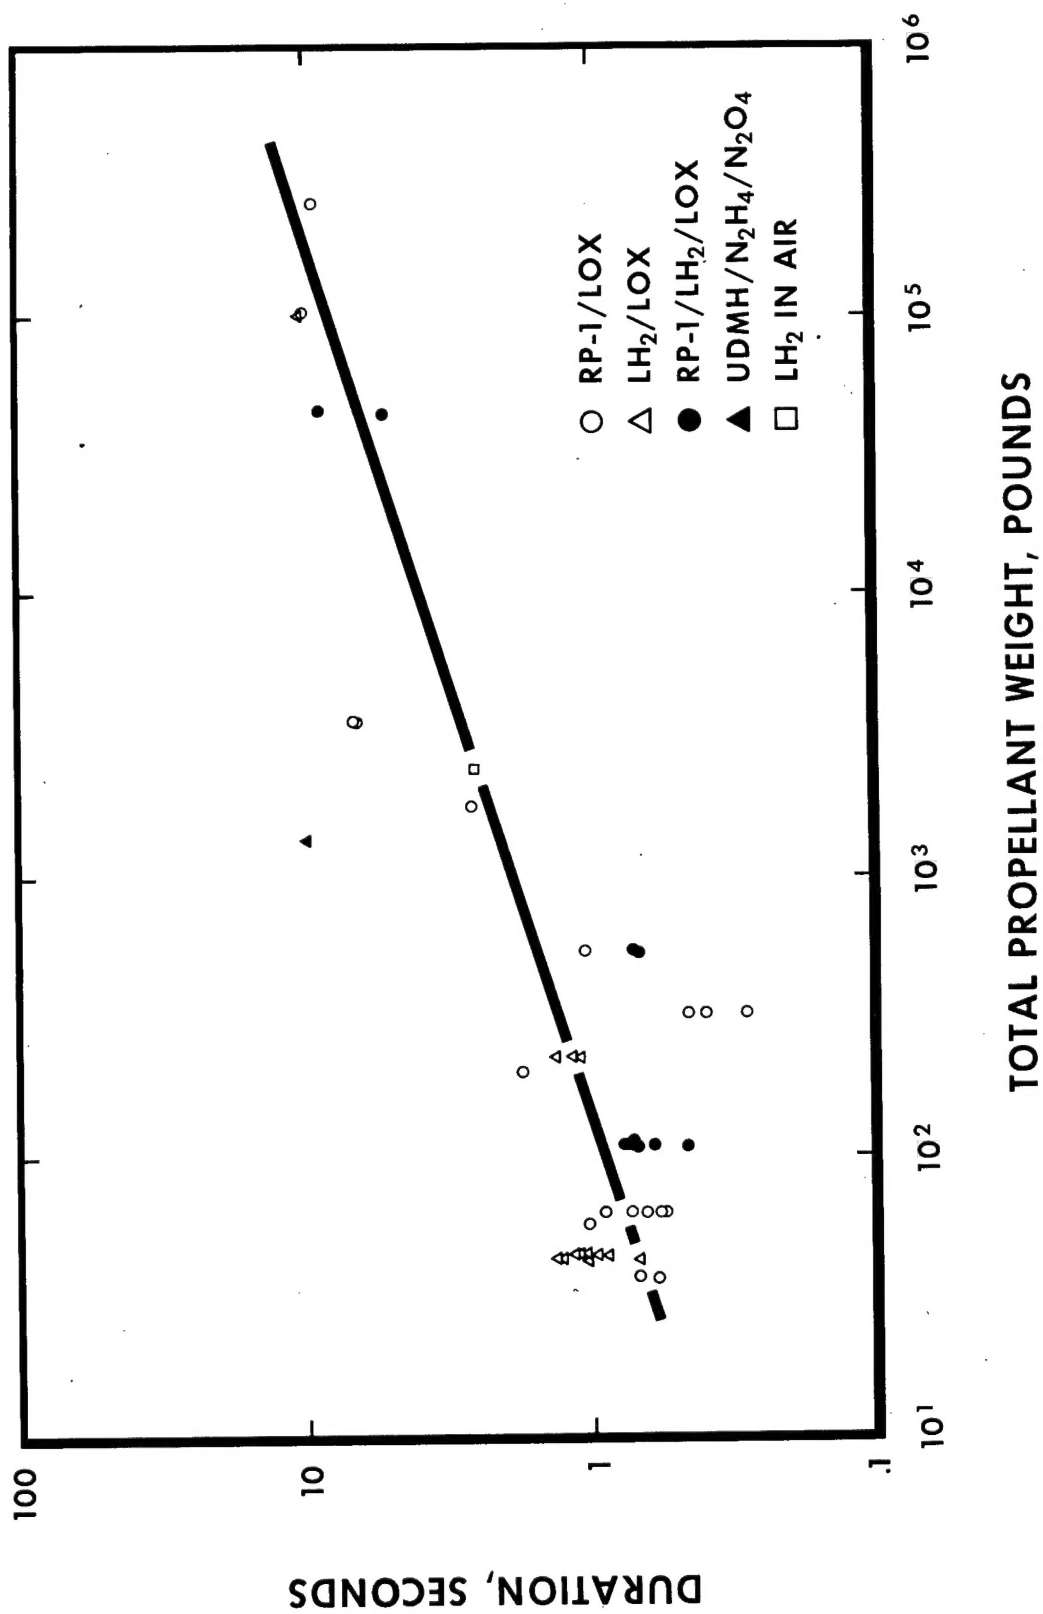
FIGURE 16. FIREBALL DURATION FOR VARIOUS WEIGHTS AND TYPES OF PROPELLANTS

Figure 16 shows the duration of the fireball together with similar values for small scale experimental studies and full scale vehicle failures. These data scatter widely and, therefore, are compatible with equations having a wide range of slopes. For consistency with the results obtained from the other explosive parameters, a slope of 0.33 is used; this appears to adequately describe the data. No doubt, much of the observed scatter is due to the difficulty in judging when the fireball has subsided.
